2003 Ford F150 Driveshaft U-joint rear Replacement

I did the replacement of the U-joint with the simplest tools I could use.

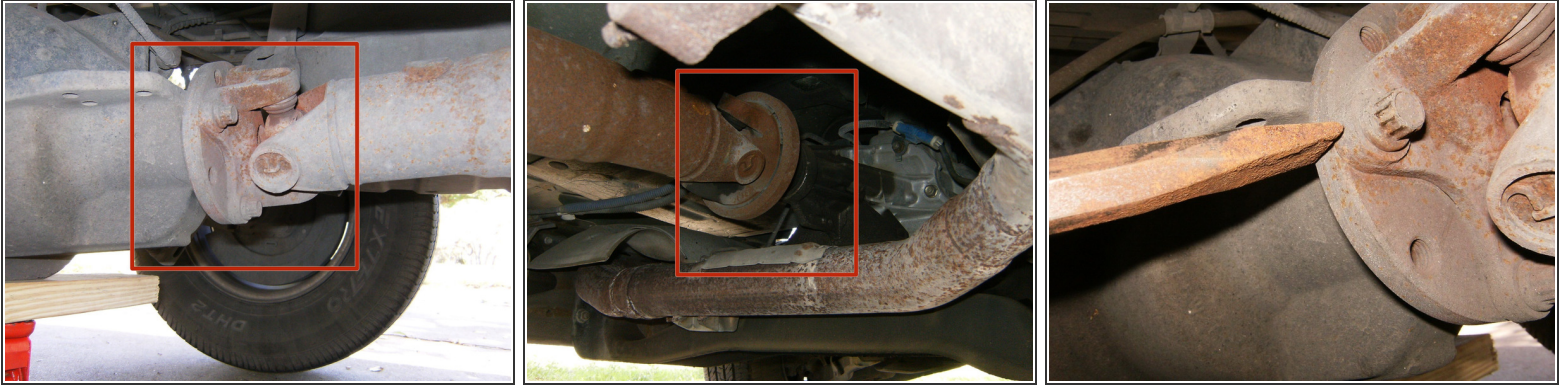
Step 1 — Driveshaft rear U-joint

- Here is a view of the rear U-joint assembly. It is connected to the driveshaft via the flange yoke. It is bolted to the rear axle at the drive pinion flange
- The front U-joint assembly connects the drive shaft and the slip yoke. The slip yoke just slides into the transmission and meshes onto the gear with its internal splines.
- Use a chisel, or similar instrument, to index the flange yoke and the pinion flange. All that does, it makes a mark across those two pieces. This will assure that the drive shaft will be mounted in the same way once the repair is done.

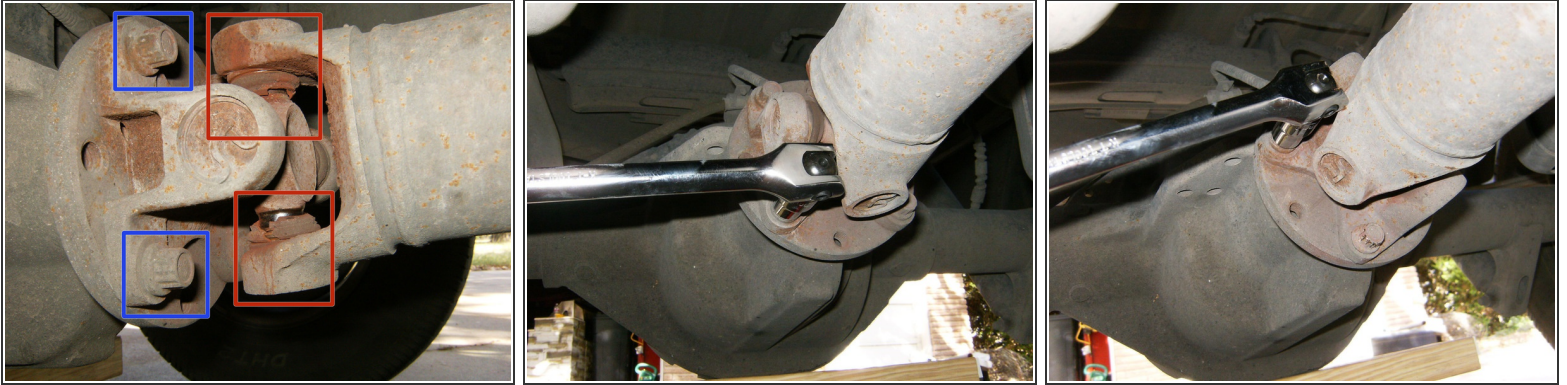
Step 2

- The damaged U-joint is clearly visible.
- There are four bolts that connect the flange to the yoke. The bolt heads require a 12mm 12point socket. A 6 point socket will not fit, and a box end wrench will not generate enough torque.
- Use a 12mm 12 point socket and a 16 inch breaker bar will generate enough torque to remove the bolt. Here a 1/2" drive socket set is used. 3/8" socket set may work as well, but the larger drive set will tolerate a bit more torquing.
- Loosen all four bolts in a criss-cross pattern.

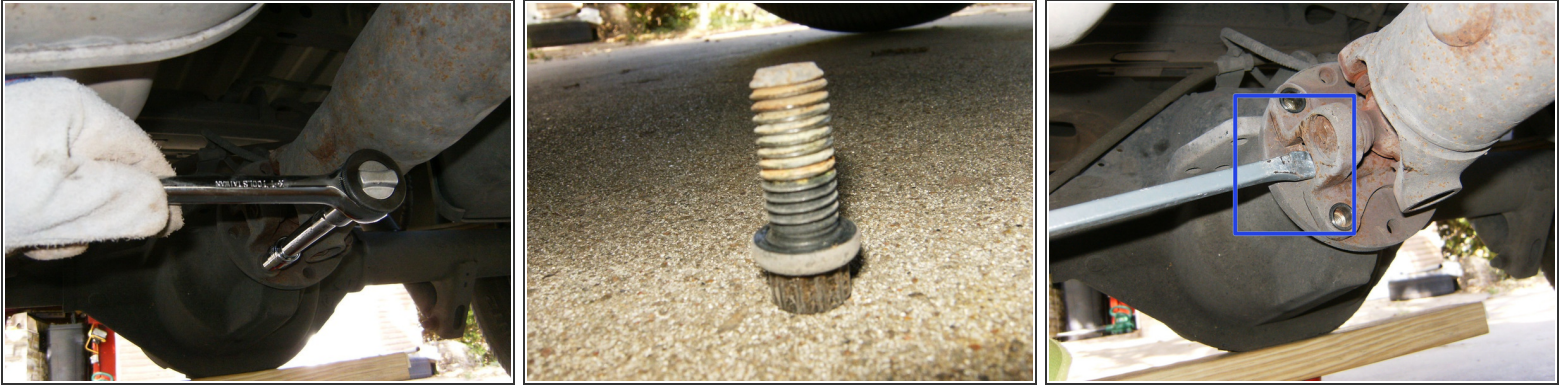
Step 3

- Use a socket and small extension to remove the bolts.
- Here is a view of the actual size of the bolt.
- The driveshaft flange yoke fits tightly on the rear axle pinion flange pilot. Do not hammer on the driveshaft or any of its components to disconnect the yoke from the flange. Pry only in the area shown, to disconnect the yoke from the flange.

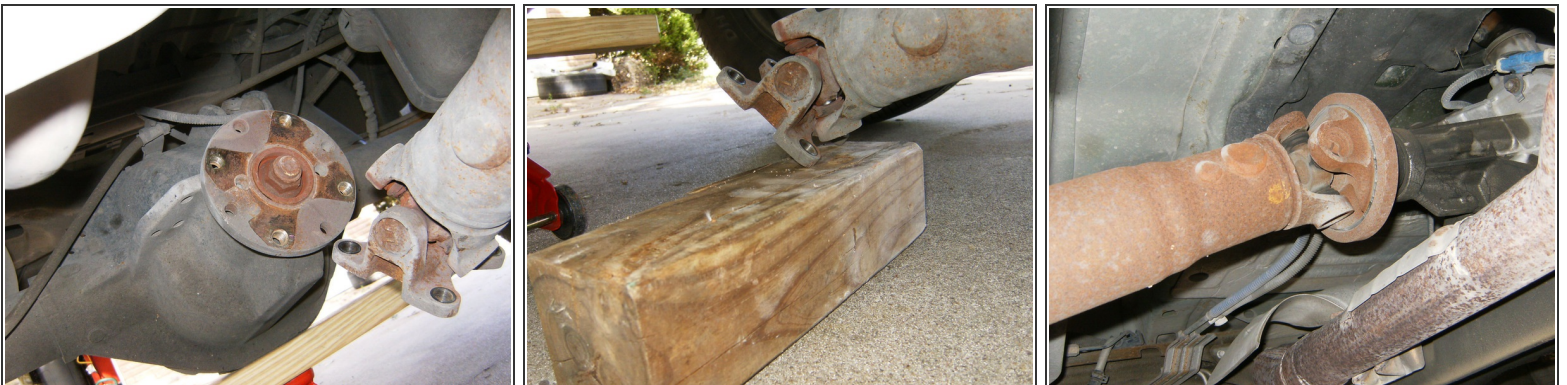
Step 4

- Driveshaft removed from the pinion flange.
- It is not very heavy, but do not let it hit the ground. Use a wooden block to set it down
- The front slip yoke still in place.

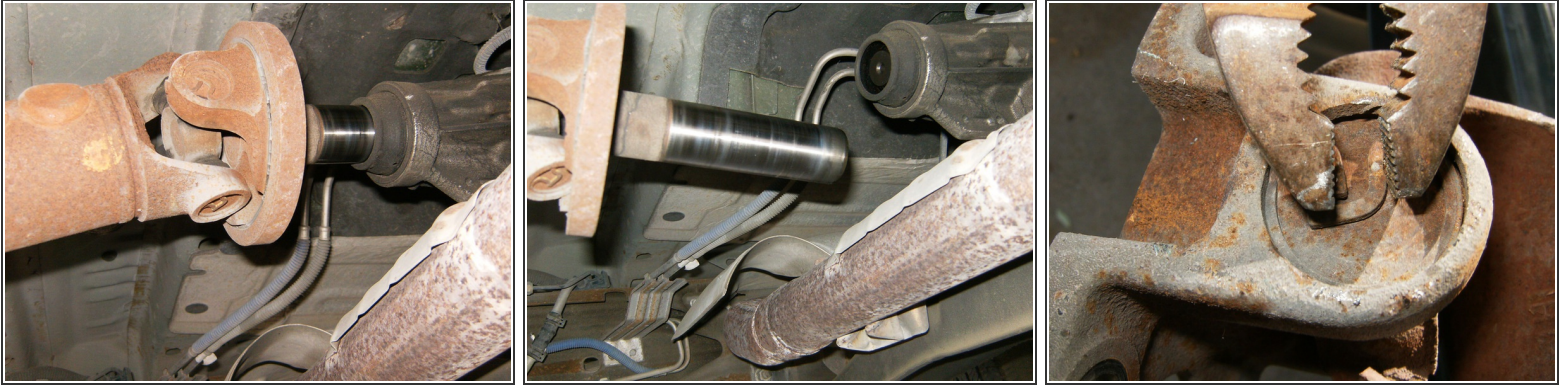
Step 5

- Lift the driveshaft of the wooden block and gently slide it to the back of the vehicle.
- The driveshaft slip yoke will simply slide out.
- Remove the driveshaft from under the vehicle and place it on a suitable place (large workbench or even the ground)
- Remove the snap ring that secure the bearings. Use a pair of pliers and squeeze the angled ends of the snap ring together. this will compress the ring.

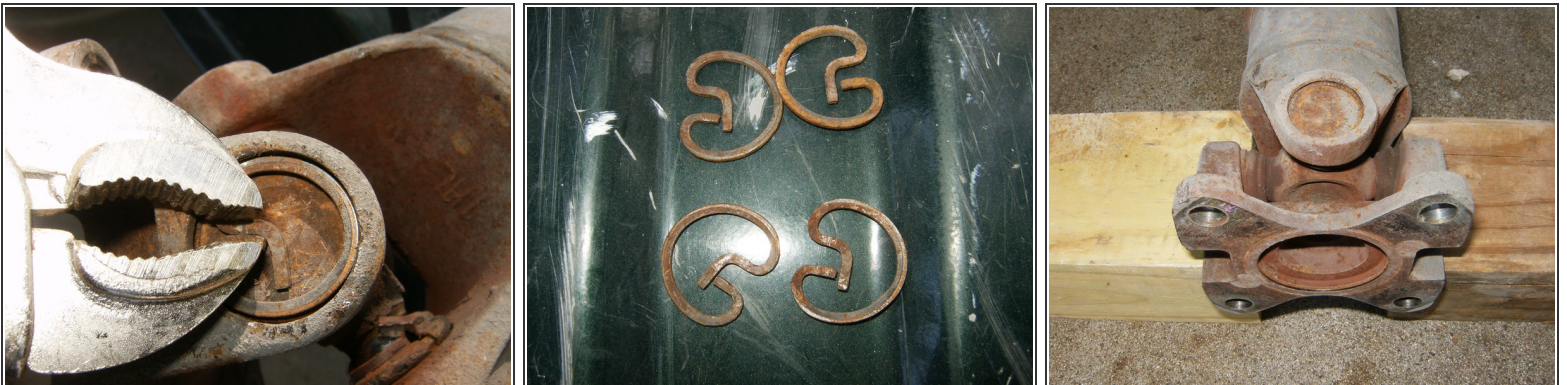
Step 6

- When the ends are properly compressed the ring will clear the inside of the groove and can be removed.
- Here are the four old snap rings. Discard those, do not reuse.
- All snap rings removed. Place the driveshaft over a block of wood so that the flange yoke will clear it.

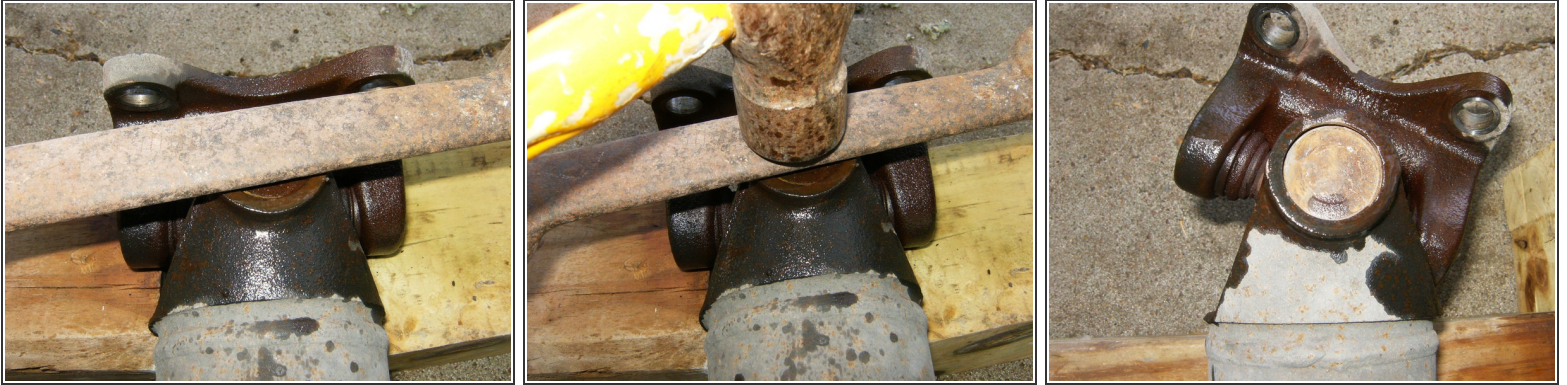
Step 7

- Application of some lubricant may assist in loosening some of the rust and debris that may have collect between the bearing cup and the bearing hole itself. Place a piece of flat metal stock across the bearing cup.
- Use a hammer and strike the flat stock
- This will slide the yoke and subsequently the bearing up through the bearing opening in the driveshaft.

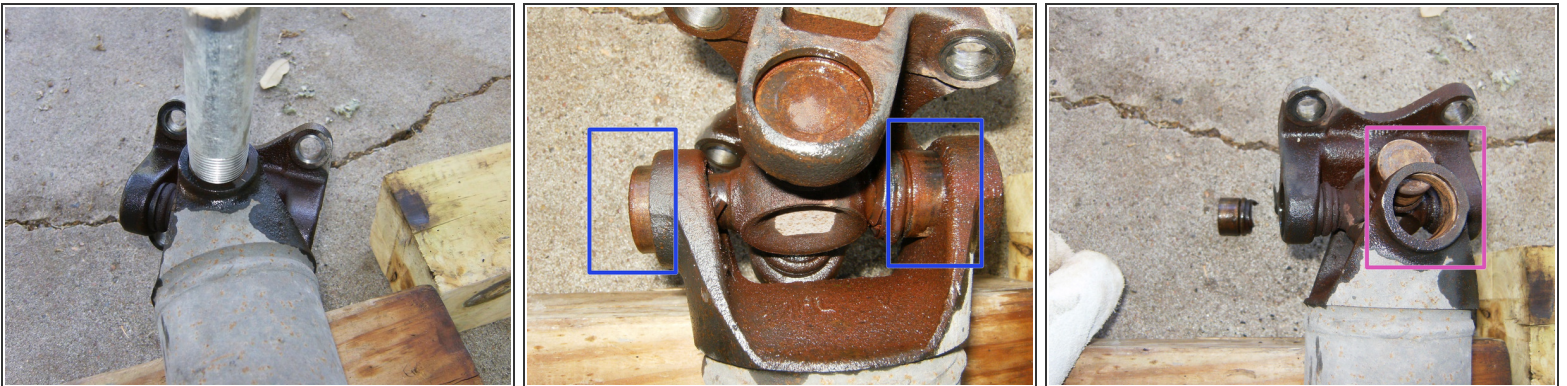
Step 8

- Turn the driveshaft 180degrees and use a tool that will fit inside the bearing hole of the drive shaft
- Strike the tool with a hammer. This will move the U-joint and yoke further out of the drive shaft
- It should only take 2-3 hammer strikes to move the yoke and U-joint out of the driveshaft bearing holes. The bearing cup most likely will may simply fall out.

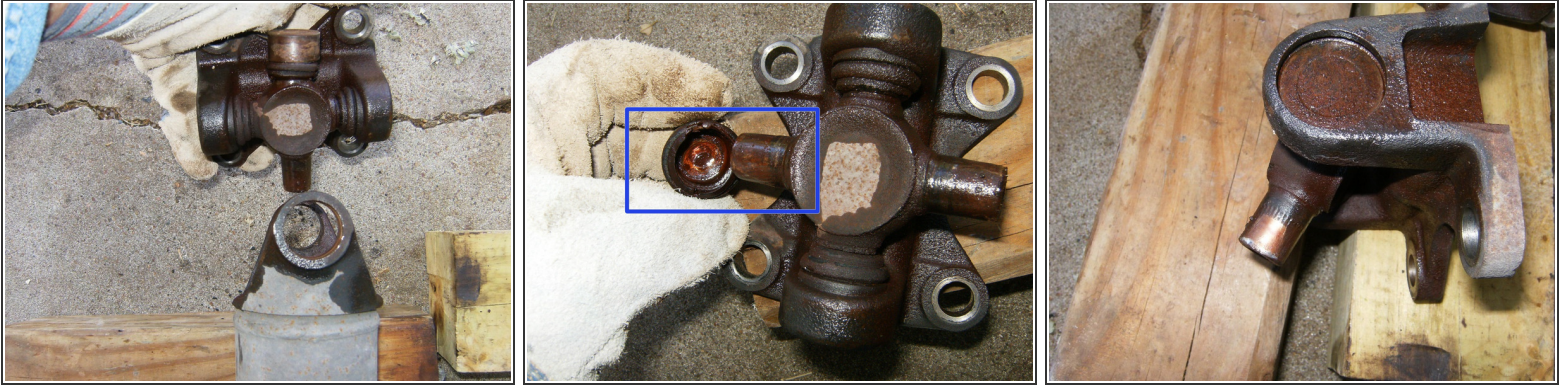
Step 9

- Remove the yoke from the driveshaft by angling it so it will clear the bearing surface.
- Here is the flange yoke with the U-joint still attached.
- Here is the damage. Missing needles out of the bearing cup, worn trunions on the joint cross.
- Place the flange yoke between two blocks of wood. Leave enough space between the blocks to clear the bearing cup.

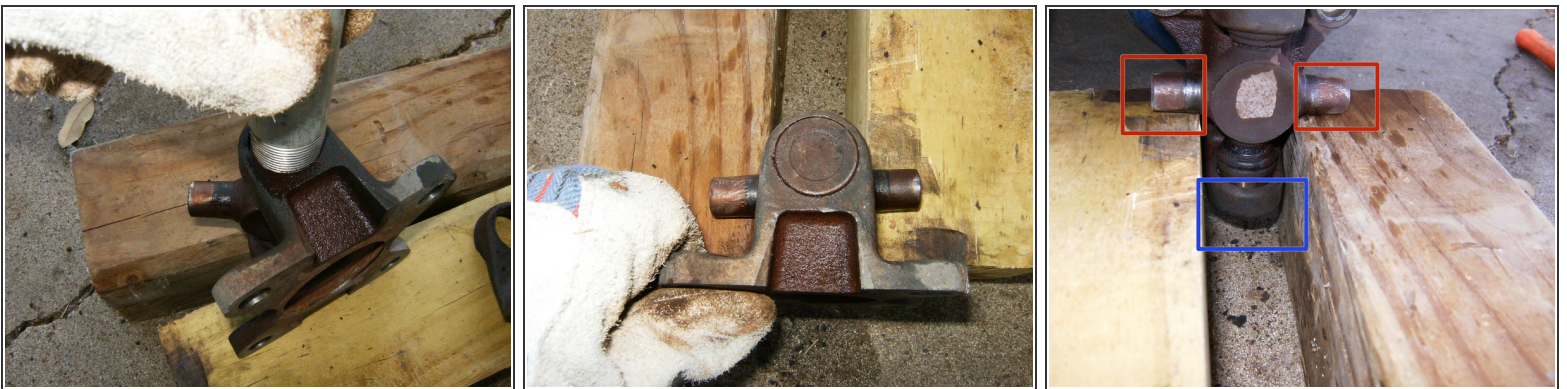
Step 10

- Use a tool that fits inside the bearing hole in the flange yoke. Strike that tool with a hammer to drive the U-joint down the opening.
- Shown here is the opposite end of the yoke. The U-joint is now flush with the yoke bearing hole.
- Position the yoke between two wooden blocks, let it rest on the trunions
- provide clearance to the bottom

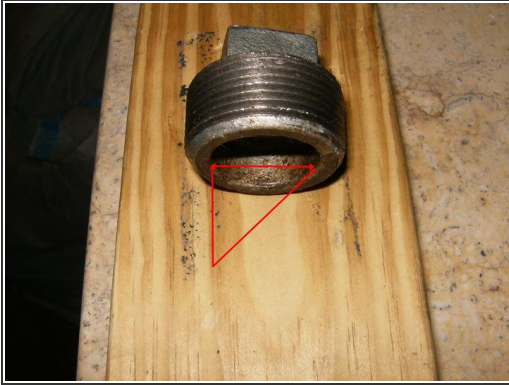
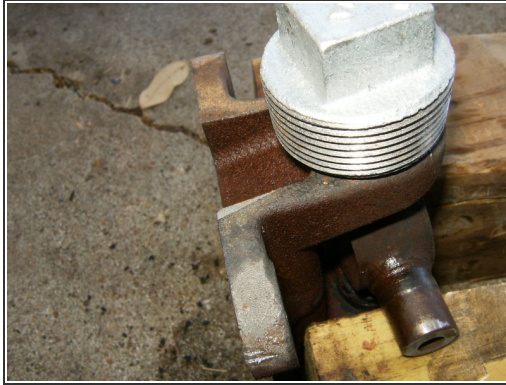
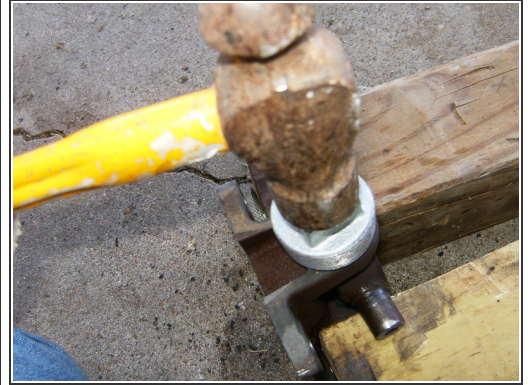
Step 11

- Here is the next tool I am using. It is a 1 1/4 galvanized plumbing plug. It has enough clearance to fit over the bearing cap.
- Place the tool over the bearing cup and rest it on the flange yoke.
- Strike that tool with a hammer

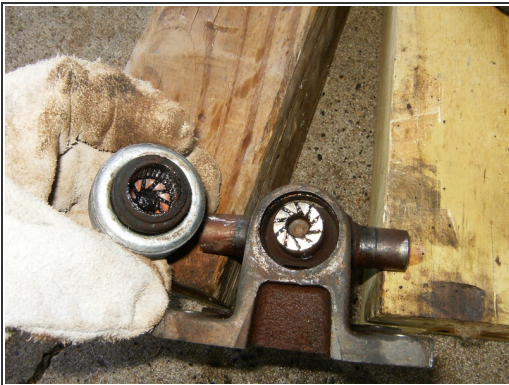
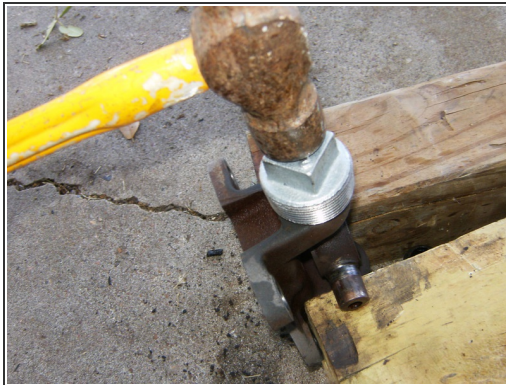
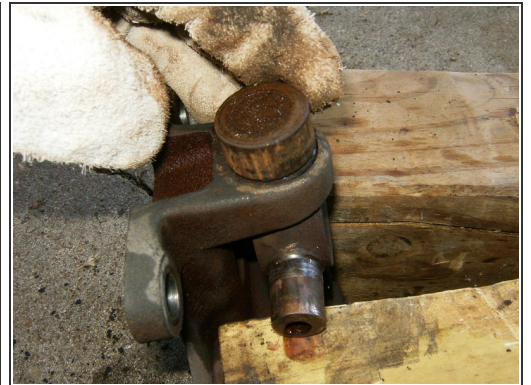
Step 12

- The yoke will move down, clearing the bearing cup. The cup may now rest inside the tool. It will be easily removed.
- Turn the yoke 180 degrees and position it between the two blocks of wood. Let the trunions rest on the wood. Place the tool over the bearing cup opening and strike it with a hammer
- The yoke will move down, clearing the last bearing cup.

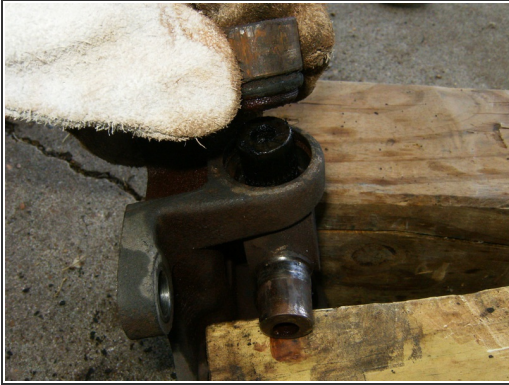
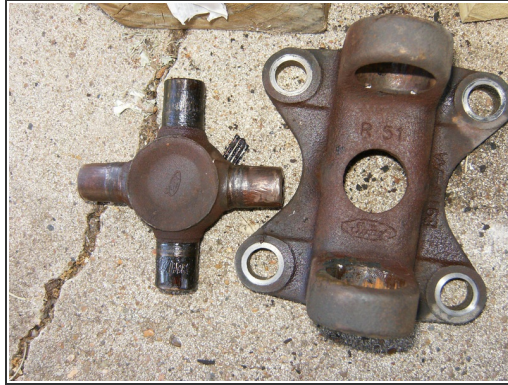
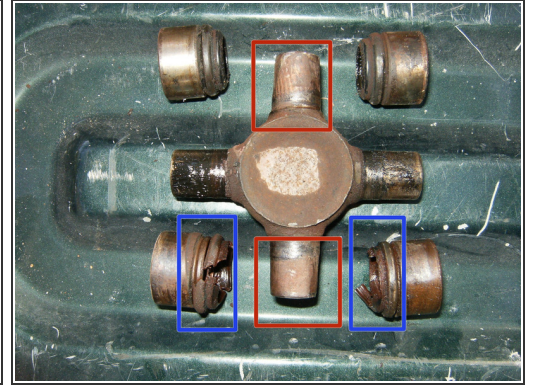
Step 13

- Remove the bearing cup.
- Remove the U-joint cross from the flange yoke.
- Show here is the damage to the trunions
 - as well as the bearing cups

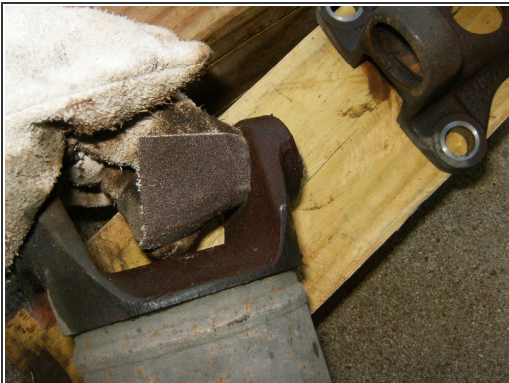
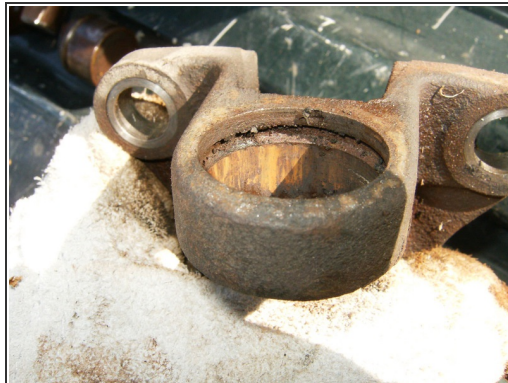
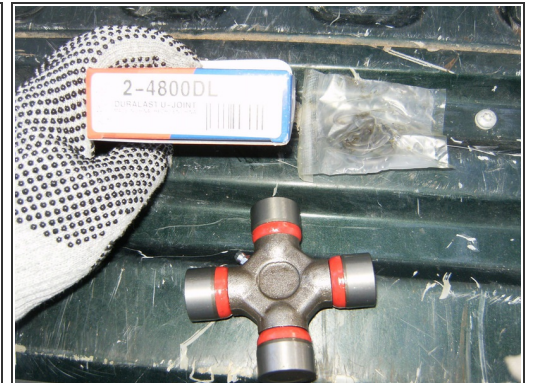
Step 14

- Clean the bearing openings with either a piece of emery cloth or a file. Deburr all the edges
- Clean the groove for the snap rings of any debris. It is imperative that these are clean to properly seat the snap rings
- Here is the new U-joint assembly for this truck. Purchased at Autozone for around \$9. This has a grease fitting that the original did not have.

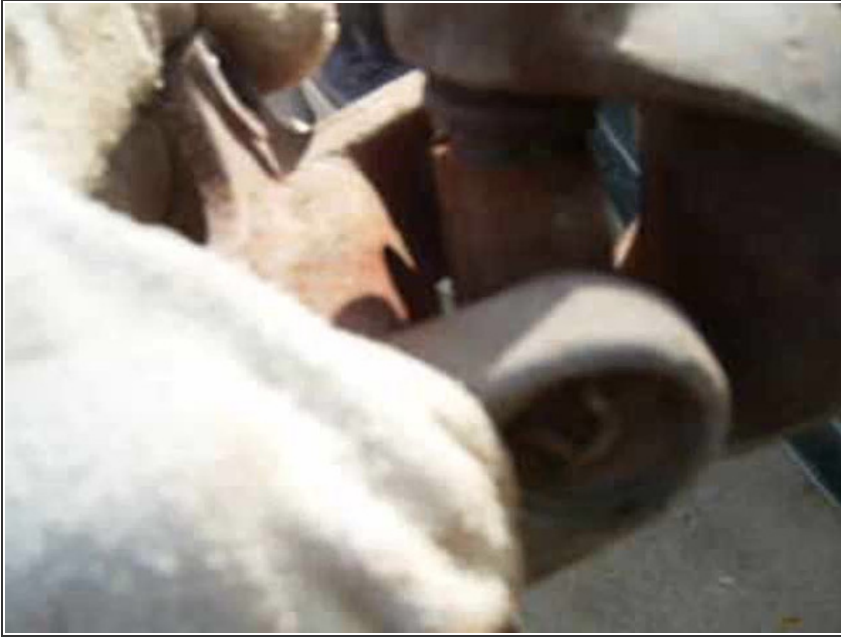
Step 15

- Here is a quick video to show how the damage affect the connection between the flange yoke and the driveshaft. If not replaced in time the trunion or bearing cup can shear of. This can cause major damage to the driveshaft, the pinion flange or the slip yoke. It will become a very expensive repair.

To reassemble your device, follow these instructions in reverse order. Ensure the needle bearings are seated straight in the bearing cup. Do not force the trunion all the way into the bearing. If it does not butt flush against it, disassemble and check for dislodged needles.
